Inspection Report

xxxx St Clair Ave
St Paul, MN 55105

Strickland Home Inspections, LLC

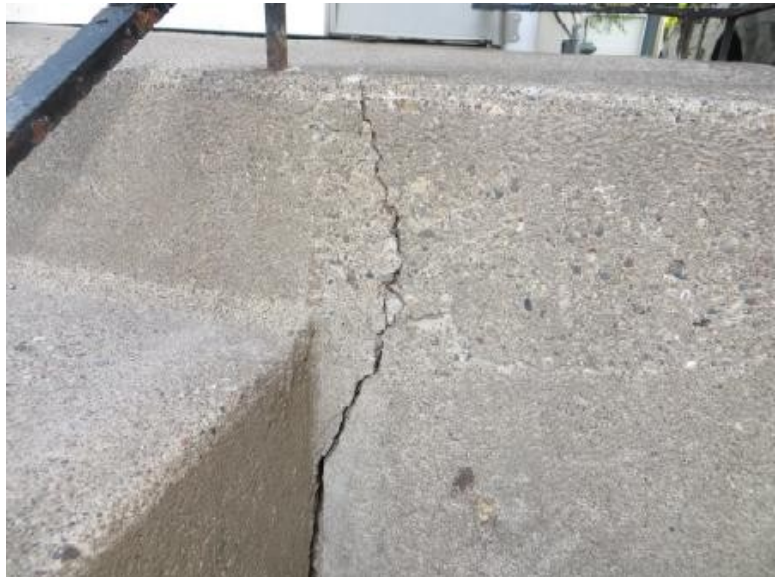
1. Walks: Concrete **Concrete walks are cracked and settled in areas. Uneven surfaces present a trip hazard.**
2. Steps/Stoops: Concrete **Front stoop is cracked. Uneven riser height presents a trip hazard.**

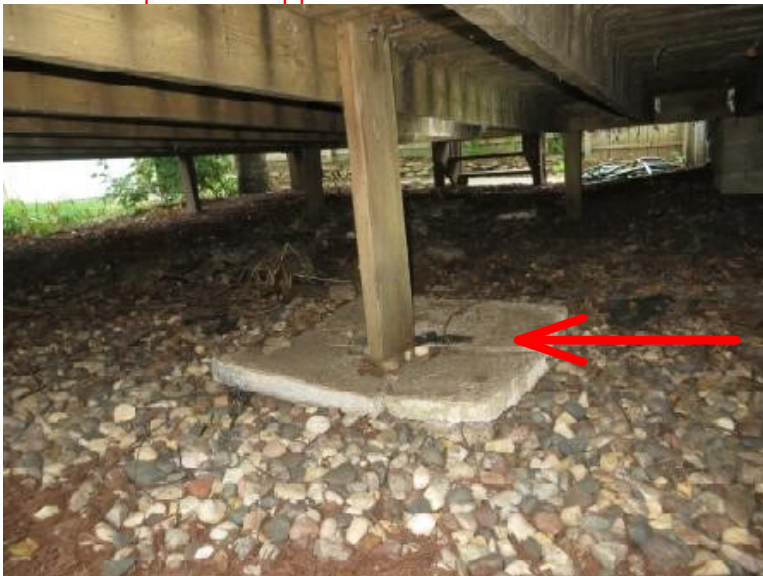
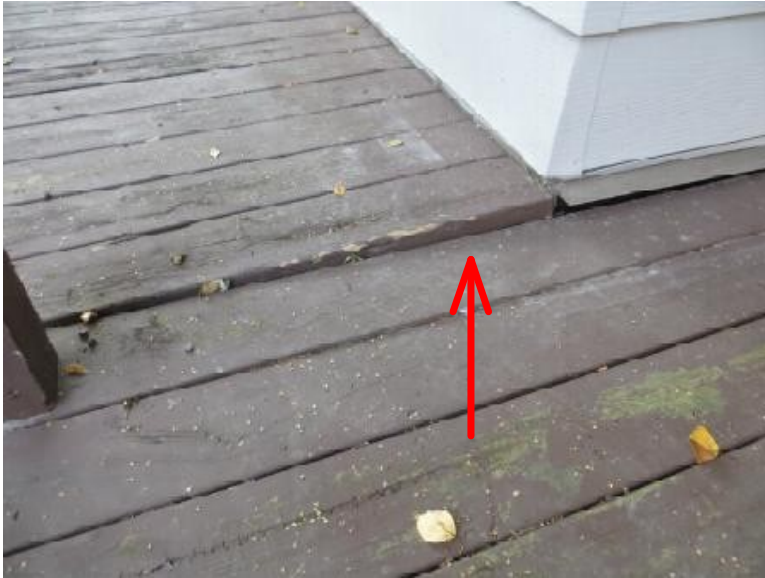
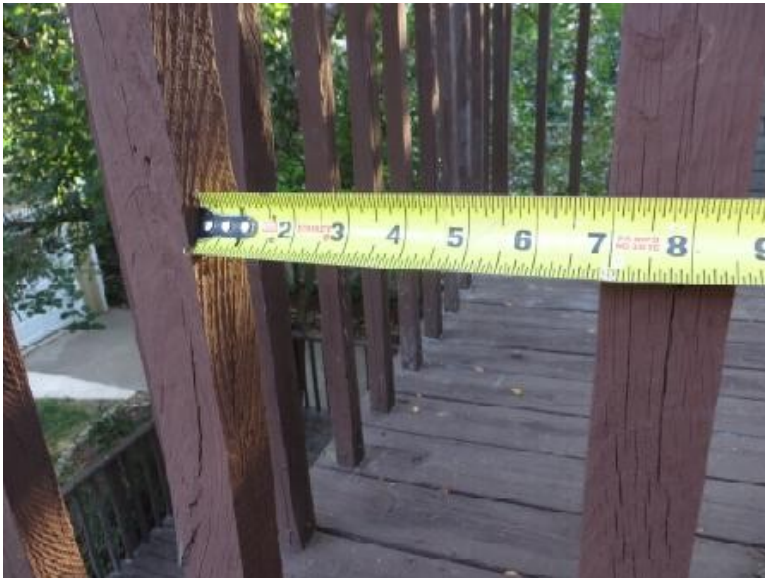
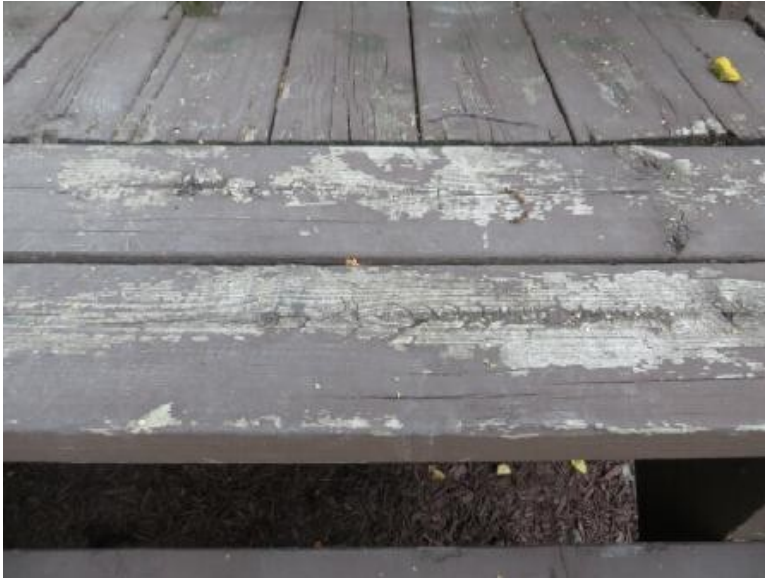
3. Deck: Stained wood **Undersized joists. Undersupported joists. Improper supports. Sagging deck. Uneven surfaces. Baluster openings greater than 4". Failing paint/stain. Recommend additional posts to support middle of deck. Recommend repairs to problem areas.**

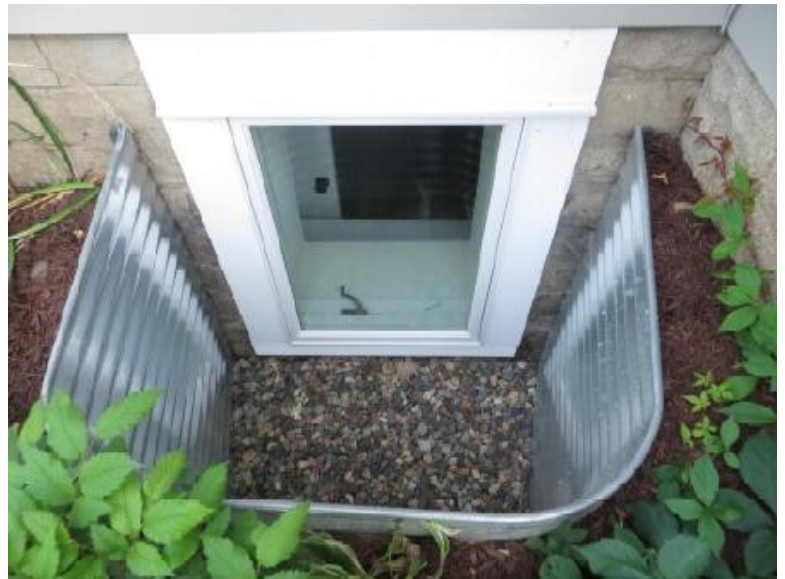
- 4. Balcony: Stained wood **Baluster openings greater than 4" at guardrail.**
- 5. Vegetation: Trees, Shrubs
- 6. Retaining Walls: Block, Stone
- 7. Grading: Flat, Minor slope **Flat to negative slope. Suggest the addition of fill dirt to improve drainage away from house.**
- 8. Window Wells: Corrugated **No ladder at south side egress window. Ladder required for heights greater than 44".**

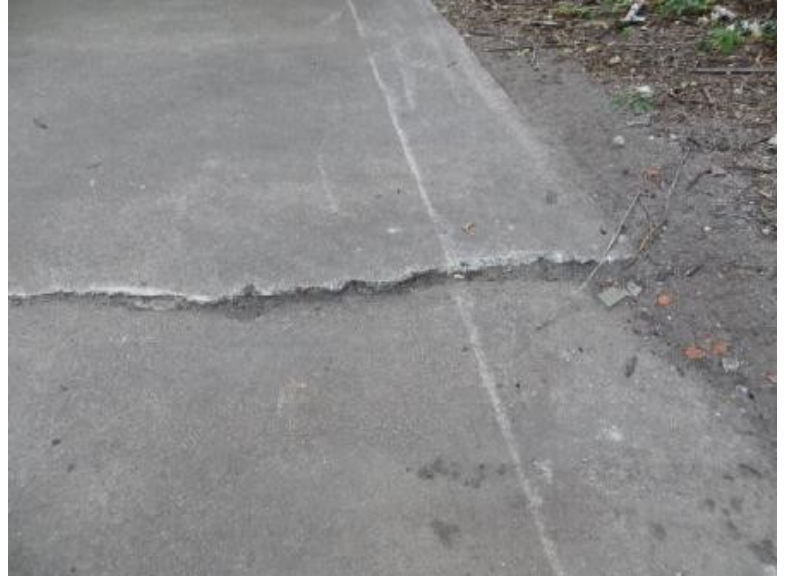
9. Driveway: Concrete **Concrete driveway is cracked and is settled in areas. There is an uneven transition where driveway meets garage.**

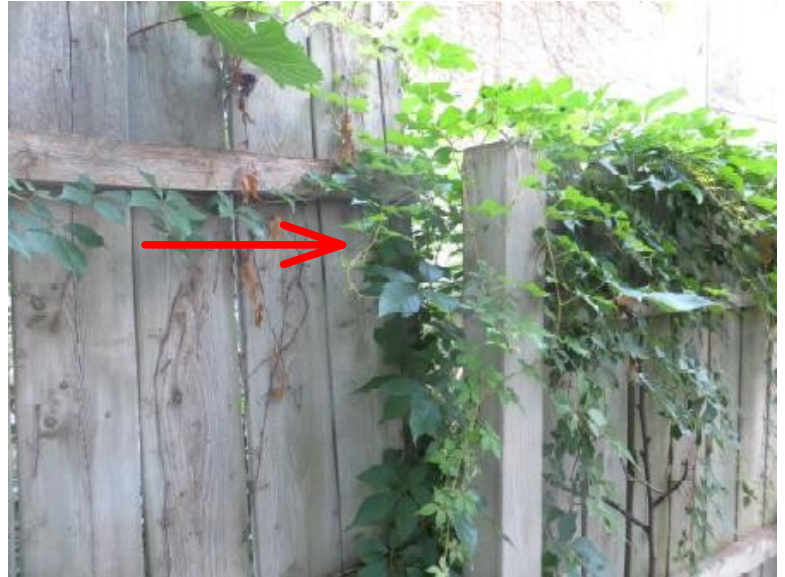
10. Fences: Wood **Some sections of wood fence are loose and/or in disrepair.**

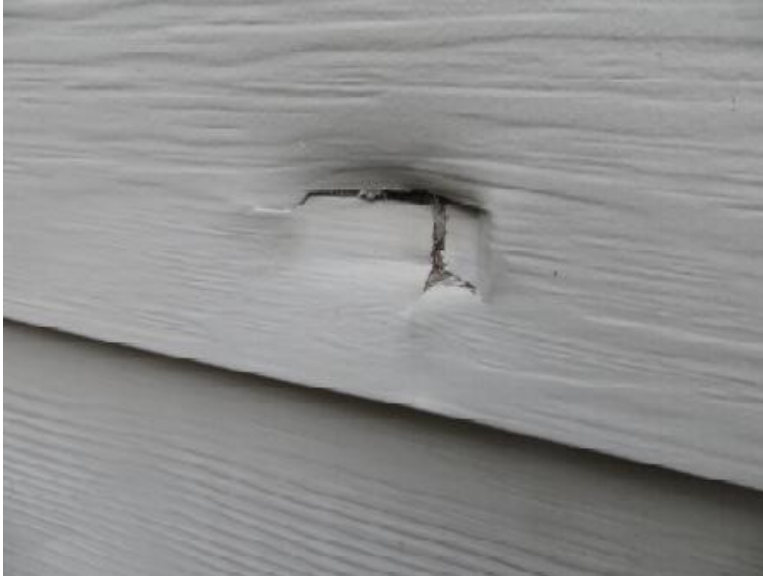
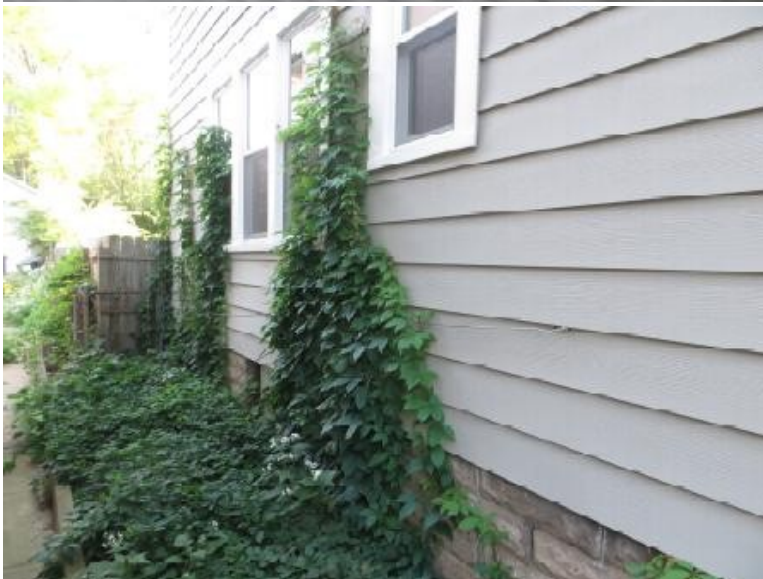
1. Type: Aluminum siding Siding is dented and has been punctured in areas. Seal penetrations. Recommend pulling ivy from NW section of wall to prevent long term damage.

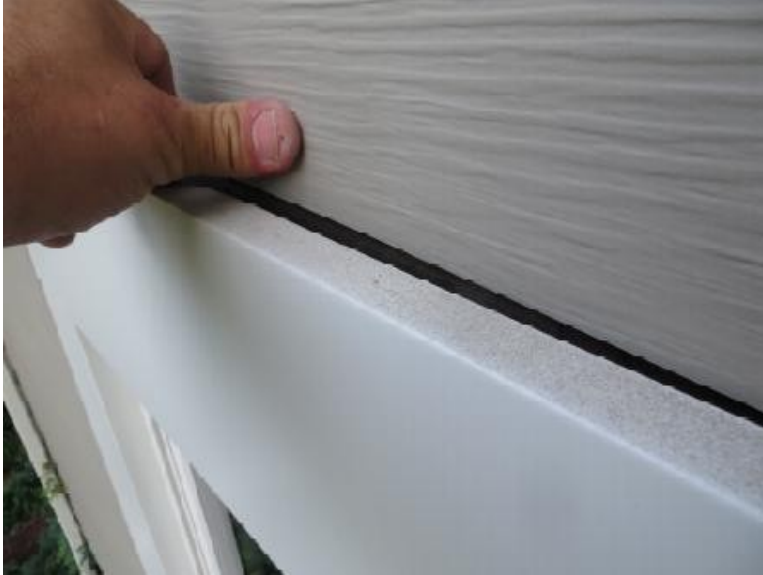
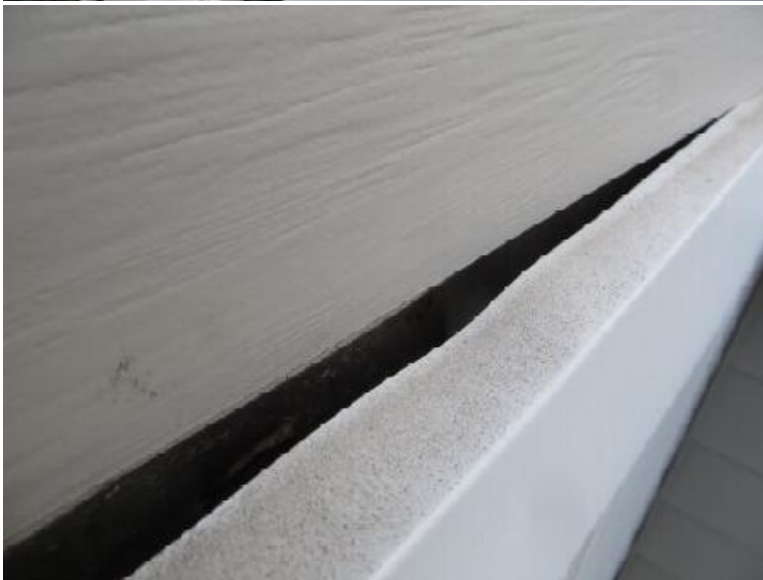
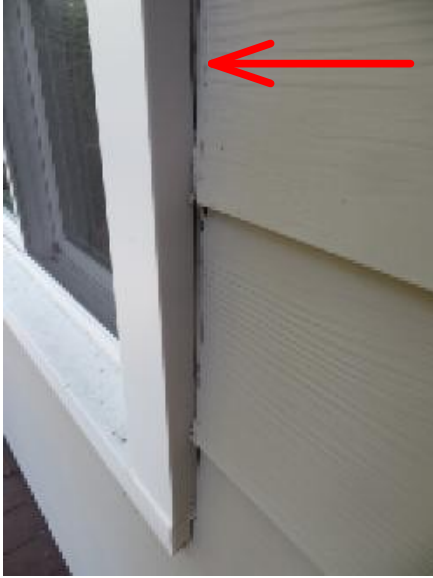
2. Trim: Metal wrapped Siding to window trim and siding to door trim junctions have not been sealed properly against water penetration. There are no drip caps above doors or windows. Transition has not been caulked. As is, water is able to run down siding and get behind metal wrapped trim. Guaranteed future water issues will result if situation is not corrected.

1. Trim: Metal wrapped Siding to window trim and siding to door trim junctions have not been sealed properly against water penetration. There are no drip caps above doors or windows. Transition has not been caulked. As is, water is able to run down siding and get behind metal wrapped trim. Guaranteed future water issues will result if situation is not corrected.

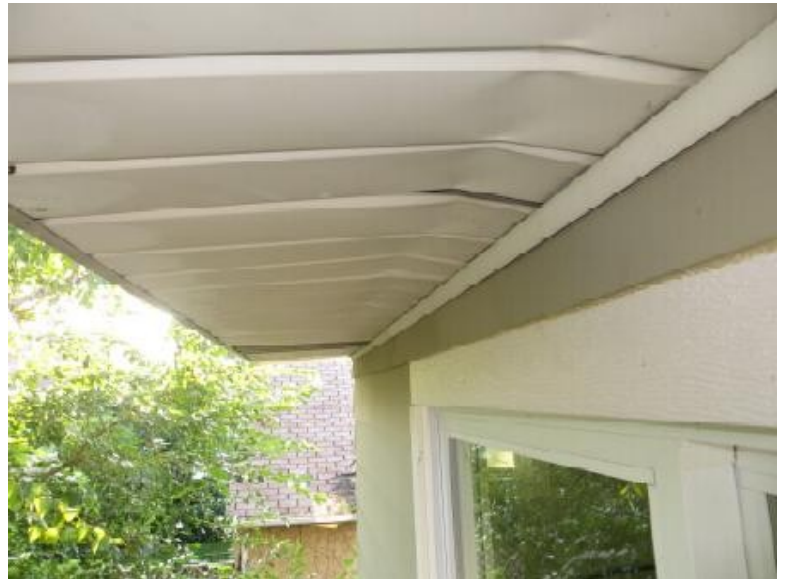
- 3. Fascia: Metal wrapped
- 4. Soffits: Metal **Some soffit areas are damaged.**

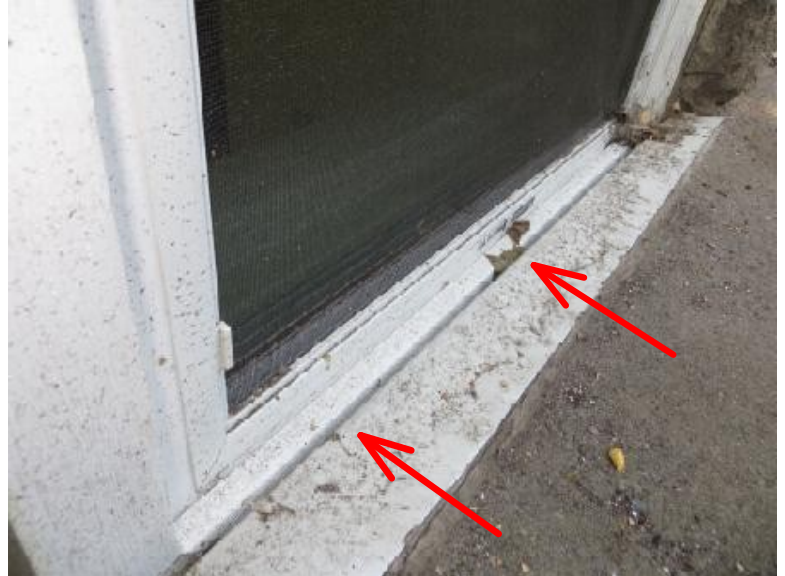
9. Basement Windows: Vinyl hopper, Vinyl casement **Basement window at SE is not sealed properly.**

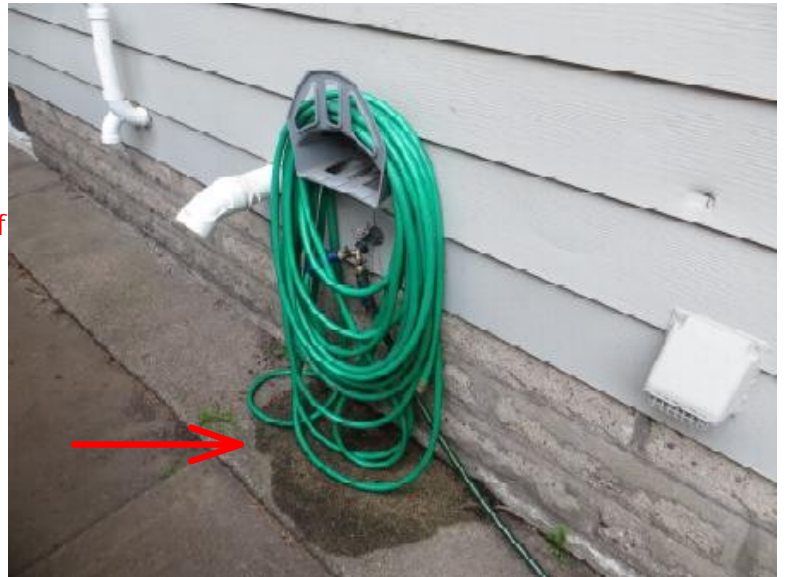
10. Exterior Lighting: Surface mount
11. Exterior Electric Outlets: 110 VAC GFCI
12. Hose Bibs: Gate **No anti-siphon device in place. Recommend the addition of a back-flow preventer to prevent hose water from siphoning back into the main water system. Signs of past or present leakage. Recommend repair or replacement of faucet.**

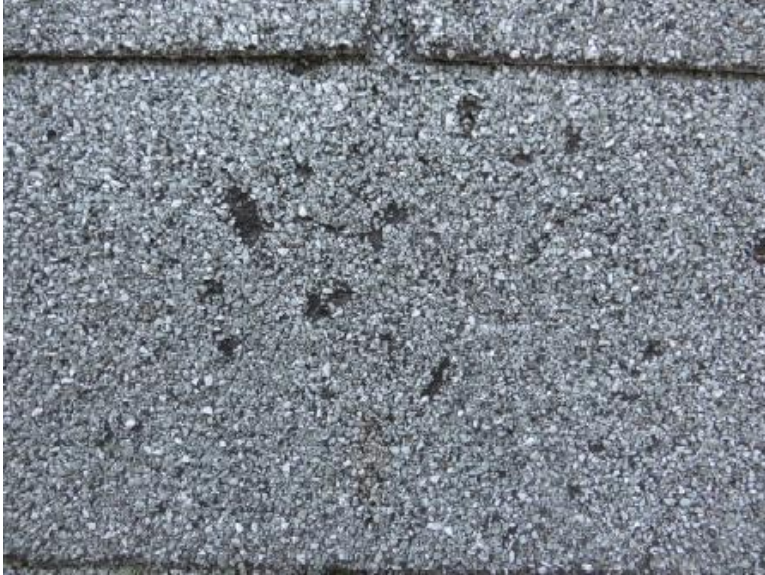
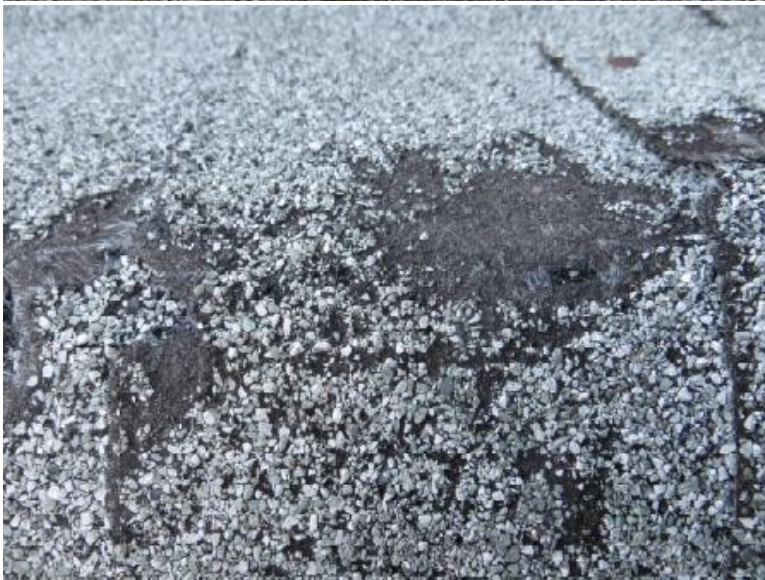
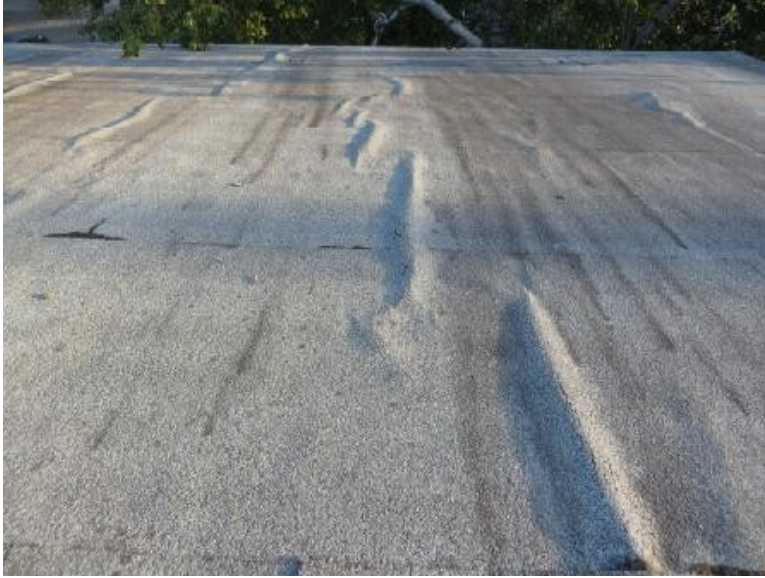
3. Material: Fiberglass shingle, Rolled roof material Areas of damage. Roof is nearing the end of its useful life. Recommend qualified roofing contractor to asses and estimate cost of replacement.

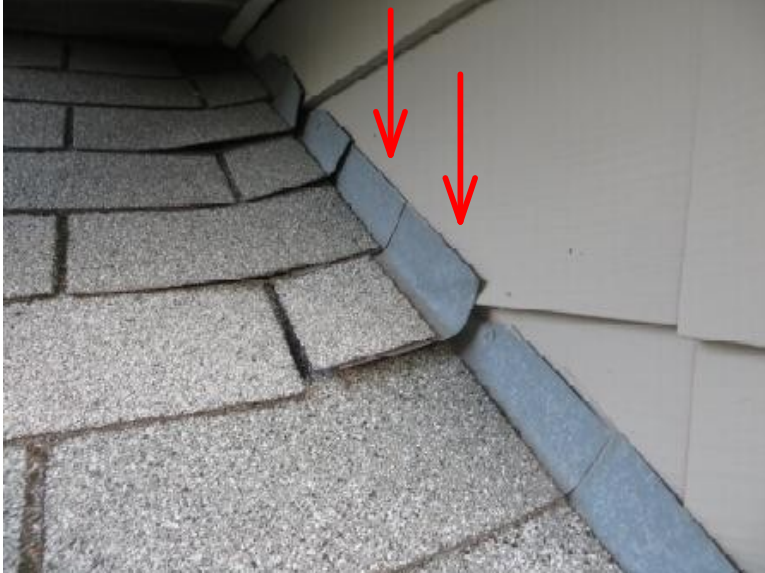
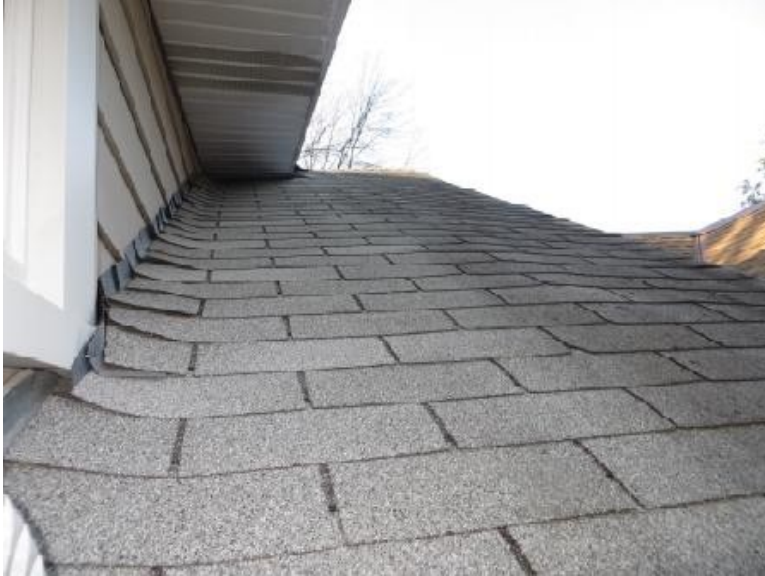
6. Flashing: Aluminum, Galvanized **Improper installation of step flashing allows water to penetrate behind flashing leading to eventual water issues.**

2. Flashing: Aluminum, Galvanized Improper installation of step flashing allows water to penetrate behind flashing leading to eventual water issues.

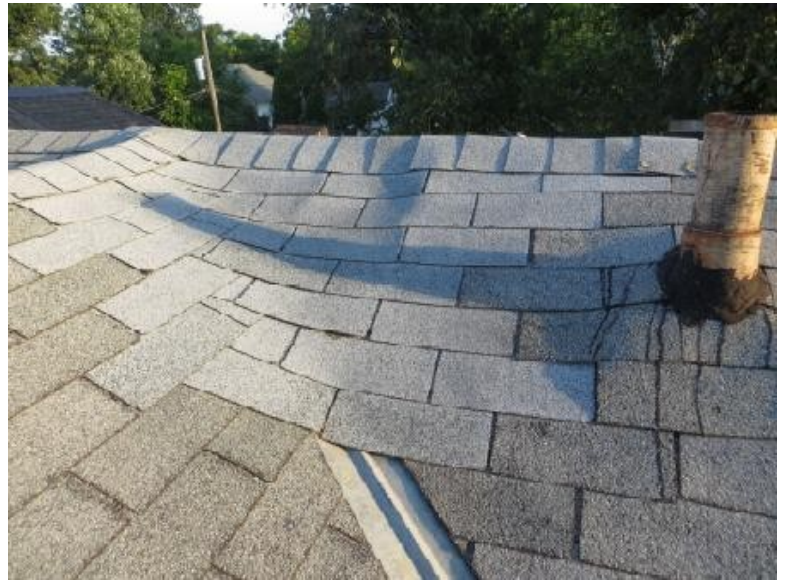
7. Valleys: Preformed metal Valleys are rusted. Roof patch at area of former chimney penetration has fiberglass 3 tab shingle as upper portion of valley and is incorrect installation.

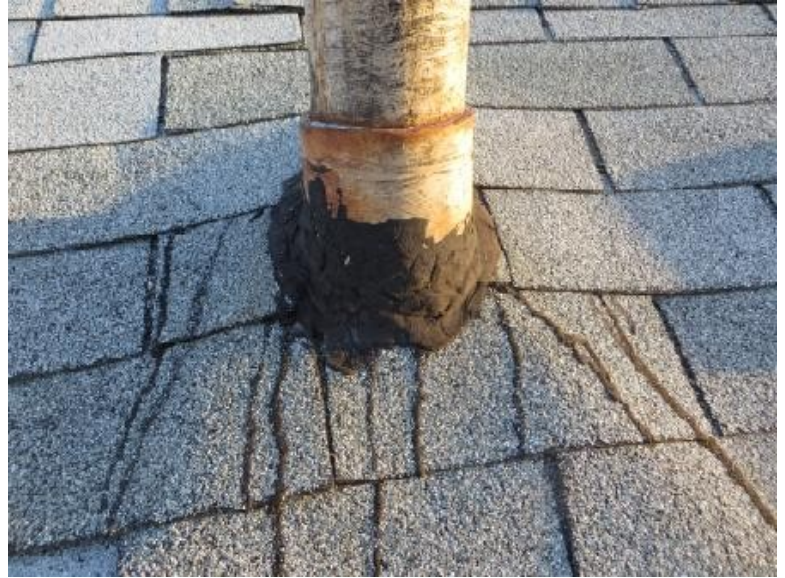
10. Plumbing Vents: Cast Iron Tar flashing shows signs of wear. Recommend new flashing.

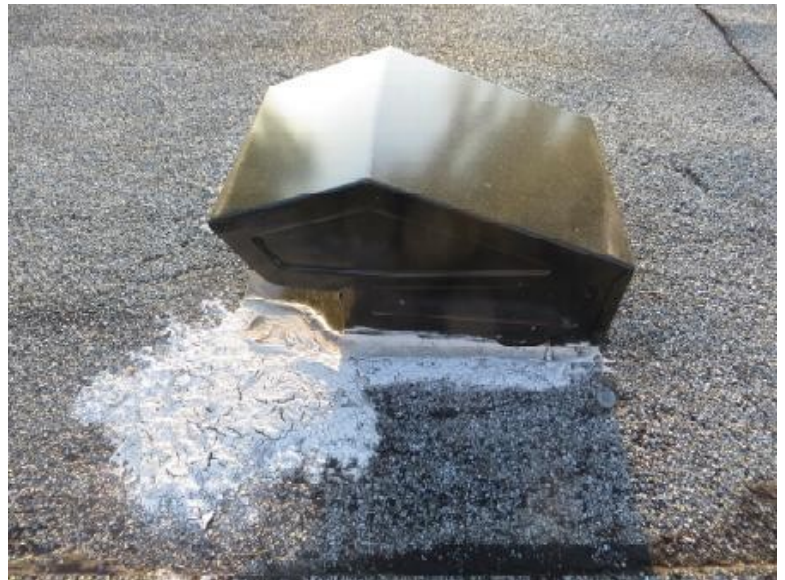
11. Mechanical Vents: Bath fan Bath exhaust hood shows excessive caulking, indicating probable previous water intrusion. Recommend resealing to ensure water-tight seal.

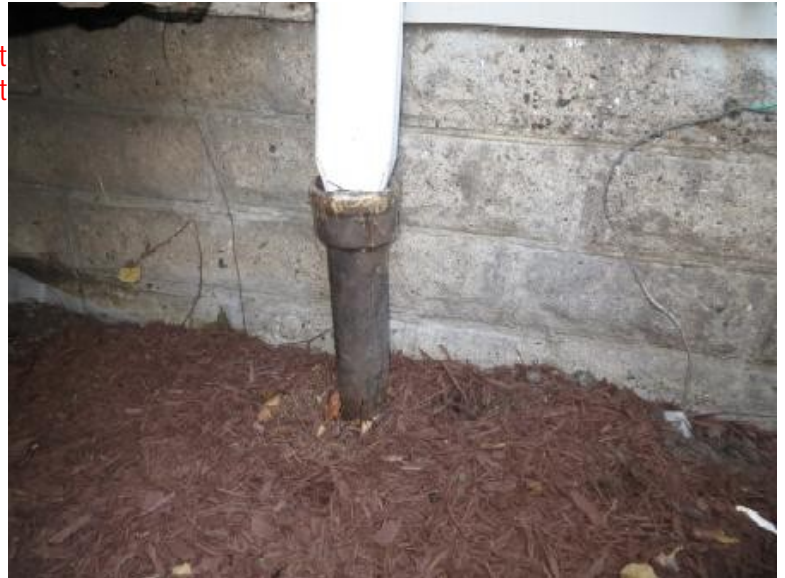
15. Leader/Extension: Aluminum
Downspout drains to cast iron pipe at NW corner of house. Unable to detect where cast iron discharges. Drainage to city sewer system is no longer permissible.

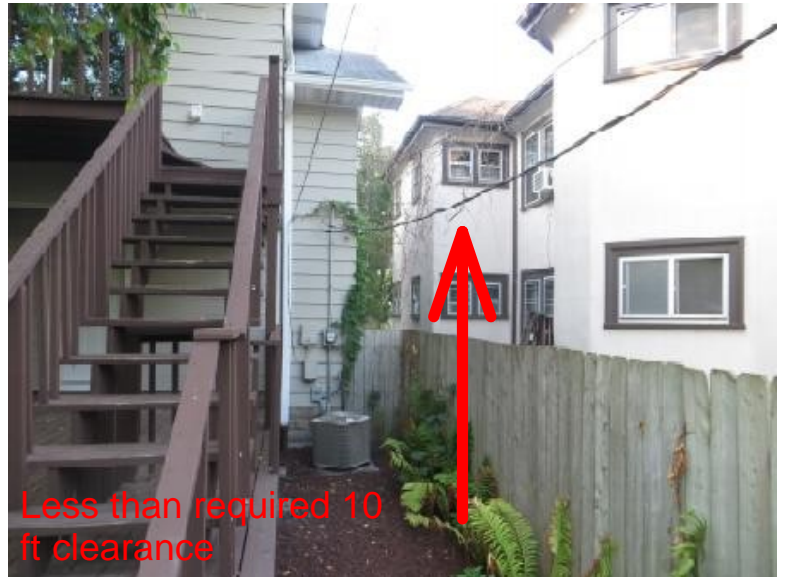
1. Service Size Amps: 100 Volts: 110/220 VAC
2. Service: Copper **Low service wires. Service wires should have minimum of 10ft clearance over ground surfaces. Recommend correction.**

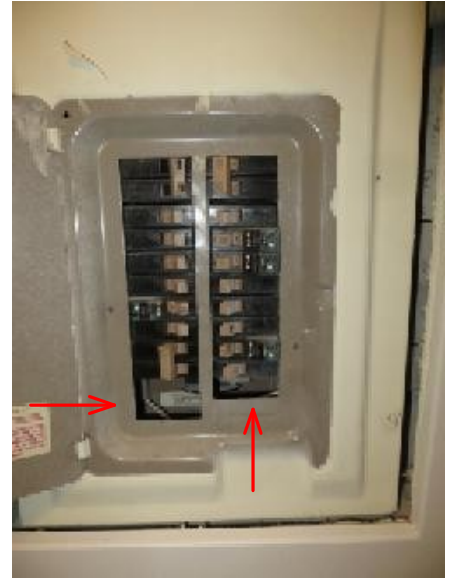
9. Manufacturer: Cutler-Hammer **Install missing knockouts.**

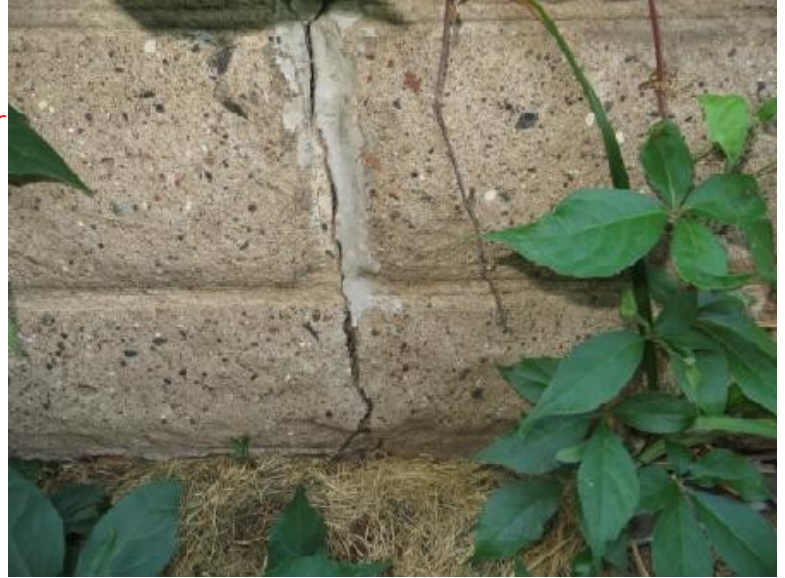
2. Foundation: Block Exterior portions of foundation show minor cracks. Recommend sealing/ tuck-pointing problem areas. Interior not visible due to finished surfaces.

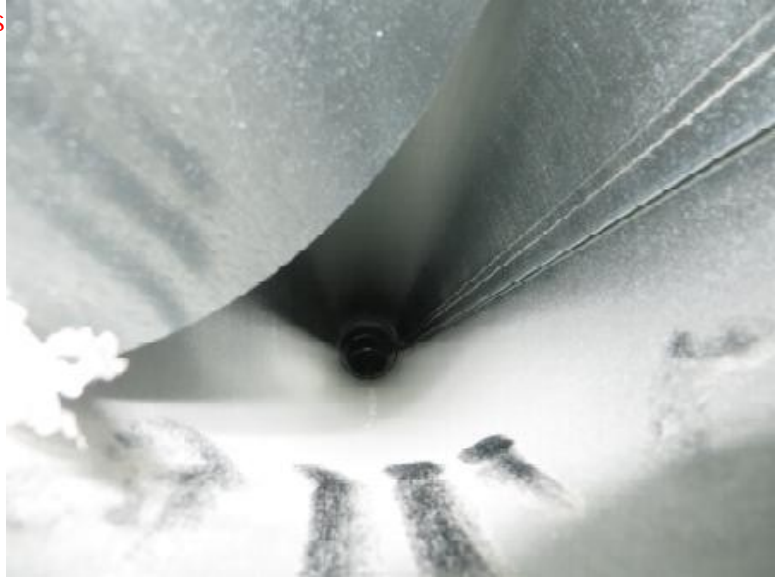
12. Exposed Ductwork: Metal Ducts are dirty. Recommend professional cleaning.

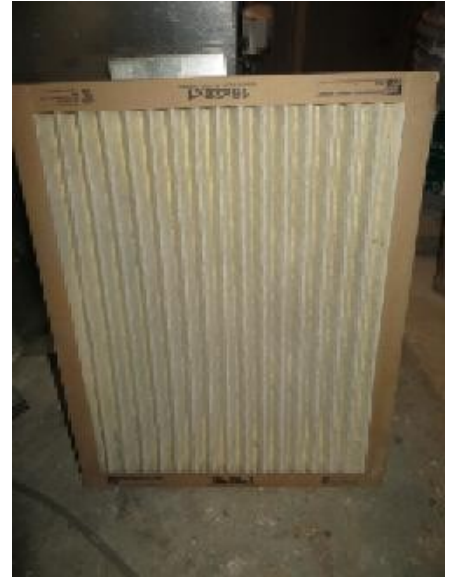
13. Blower Fan/Filters: Direct drive with disposable filter. Filter is dirty. Recommend replacing filter every 3 months.

25. Basement Heating System Blower Fan/Filter: Direct drive with disposable filter **Filter is dirty. Recommend replacing filter every 3 months See photo in air conditioning section.**
